# Manhole Inspection Summary

Manhole # S53I\_\_025MH

**Location** Address: **505 south ellwood avenue** Cross Street: **eastern avenue**

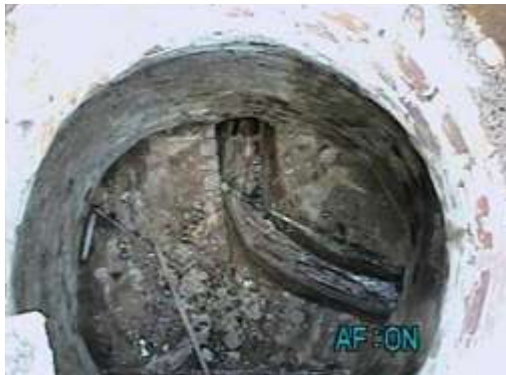
Miscellaneous

debris

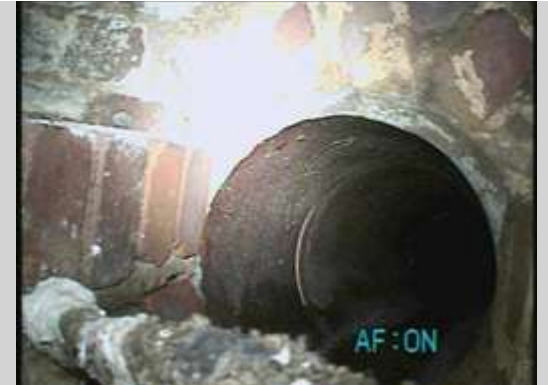
12 O'Clock Outflow

8 in. Circular Gravity Sewer  
Pipe Out @ 12 O'Clock

Pipe Material: **Clay** ☐ Pipe Lined

Invert Depth: 8.00 (ft.) Flow Characteristics: **Fast**

Deposits: ☒ None ☐ Mud ☐ Sludge ☐ Debris ☐ Grease

Infiltration: **None** Pipe Seal Cond: **Unknown**

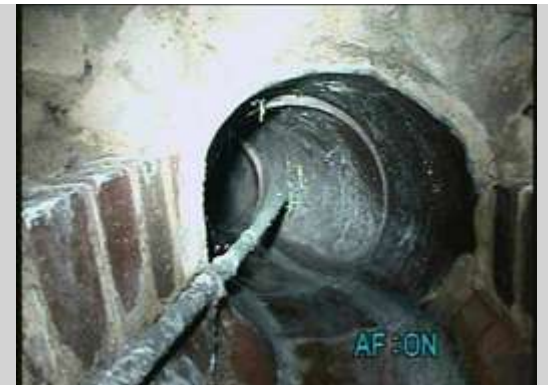
4 O'Clock Inflow

8 in. Circular Gravity Sewer  
Pipe In @ 4 O'Clock

Pipe Material: **Clay** ☐ Pipe Lined

Invert Depth: 7.50 (ft.) Flow Characteristics: **Fast**

Deposits: ☒ None ☐ Mud ☐ Sludge ☐ Debris ☐ Grease

Infiltration: **None** Pipe Seal Cond: **Unknown**
